**Flood Control Project Maintenance
Levee Inspections**
LMA District Cover Sheet
Spring 2018 Levee Inspection Results

Reclamation District No. 0999 Netherlands

Spring 2018 Levee Inspection Results

Waterway			Bank	Unit Miles
Unit No. 01 Yolo Bypass			Left	15.41
	Spring (March - May)	Summer (June - August)	(September - November) Fall	Winter (December - February)
Unit Maintenance Rating (Fall Only)				
Date of Inspection	5/8/2018 - 5/8/2018			
DWR Inspector	Dave Torres			
Accompanied By	Tom Slater RD999

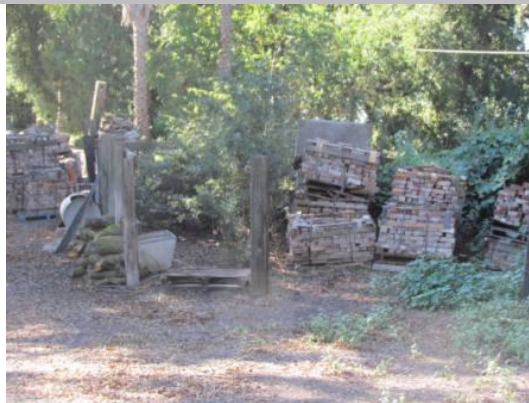
Photo 3 of 4 : SP_2018_RD0999_236_96_20180301_00051.jpg

Looking south at firewood and other material on landside shoulder and crown.

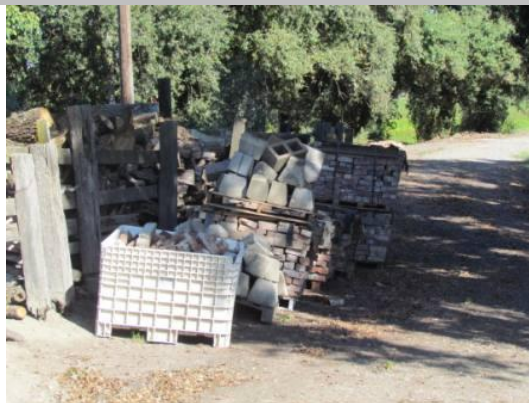
Photo 4 of 4 : SP_2018_RD0999_236_96_20180301_00052.jpg

LM Start	6.73	Rating **	M	Issue No.	96 (cont)	
LM End	6.73	Issue Type +	En	Location *	LS	
Category	Earthen Levee			GPS Latitude/Longitude		
				Start		End
Item	Encroachments			38.395234 °		38.395234 °
				-121.539323 °		-121.539323 °
DWR ID	DWR_RD0999_05_s_2012_96					
Comment Code						
MA : Material						
Inspector Comment						
Firewood and other material on landside shoulder.

Looking north at firewood and other material on landside shoulder and crown.

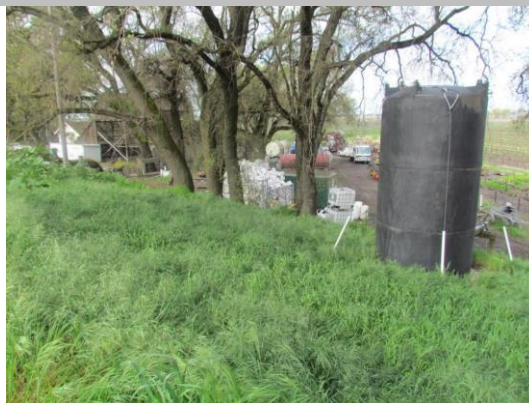
Photo 1 of 2 : SP_2018_RD0999_236_226_20180301_00128.jpg

LM Start	6.76	Rating **	U	Issue No.	226
LM End	6.76	Issue Type +	En	Location *	LS
Category	Earthen Levee			GPS Latitude/Longitude	
				Start	End
Item	Encroachments			38.395668 °	38.395668 °
				-121.539149 °	-121.539149 °
DWR ID	DWR_RD0999_05_s_2017_226				
Comment Code					
TA : Tank					
Inspector Comment					
Large water tank on landside slope and other material.

Looking west at water tank on landward slope.

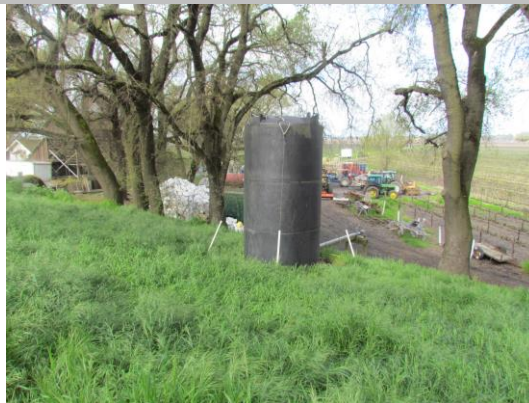
Photo 2 of 2 : SP_2018_RD0999_236_226_20180301_00129.jpg

Looking west at water tank on landward slope and toe.

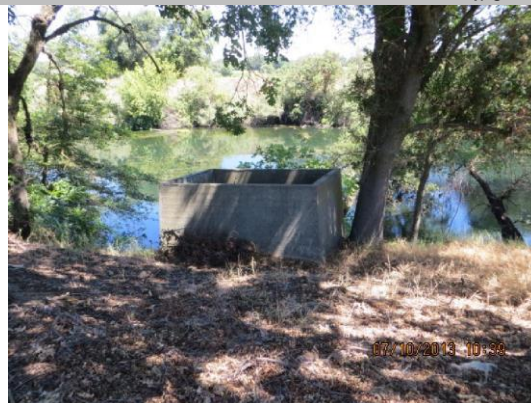
Photo 1 of 3 : UCIP_SP_2018_50096_25938.jpg

Comment Code					
Inspector Comment					
FS_ID:50096 DS_ID:22863 EP_NO: N/A Repair Type: Urgent Crossing Status: Found UCIP Comments: 07/07/2016 - Pipe abandoned and appears to be open inside the concrete box on the WS shoulder. No appurtenances visible from the LS. (T. Hatch/UCIP)07/10/2013 - Pipe abandoned and open on both ends. Concrete pump pit foundation undermined at WS toe. Pipe should be abandoned properly (W. Wylie/UCIP) FIELD_STRUCT_DESC: *ABANDONED* 14-inch (measured) steel irrigation pipe through the levee, 4.8 feet below the crown. 9-foot by 14-foot concrete pump pit on the waterside (WS) slope. Pipe open on the WS inlet to pump pit. [Additional Reference(s): DWR Levee Log, 1992, 16-inch pipe listed. USACE Sacramento O&M Manual 113 (Revised), October 1966, (HLM 7.60), abandoned 16-inch pipe listed]. FS Date: 7/7/2016

Concrete pump pit on WS toe.

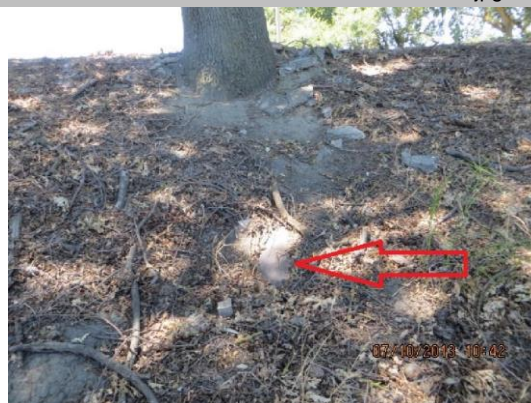
Photo 2 of 3 : UCIP_SP_2018_50096_25937.jpg

Pipe visible on WS slope.

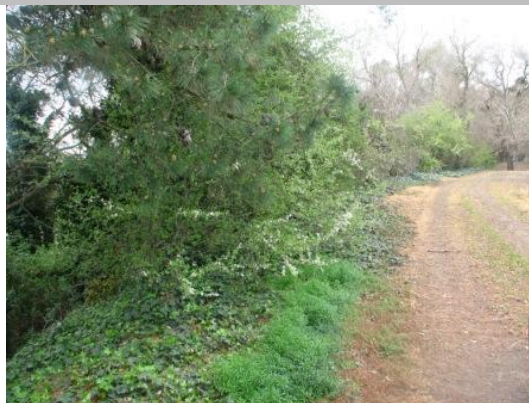
Photo 2 of 2 : SP_2018_RD0999_236_66_20180301_00038.jpg

Landscaping on landside slope blocking view of slope. (Spring 2016)

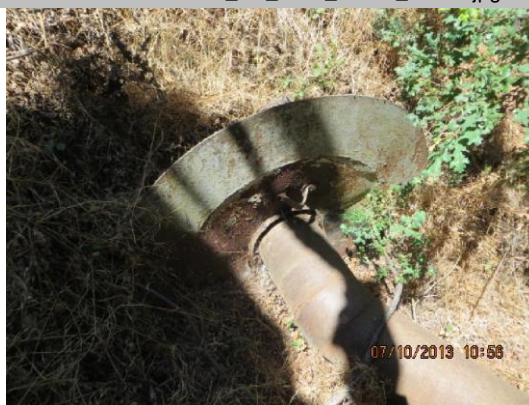
Photo 1 of 3 : UCIP_SP_2018_15624_25969.jpg

LM Start	7.57	Rating **	M	Issue No.	248
LM End	7.57	Issue Type +	En	Location *	
Category	Supplemental			GPS Latitude/Longitude	
				Start	End
Item	DWR UCIP Field Study			38.403993 °	38.403993 °
				-121.541626 °	-121.541626 °
DWR ID					
Comment Code					
Inspector Comment					
FS_ID:15624 DS_ID:22864 EP_NO: N/A Repair Type: Non-Urgent Crossing Status: Found UCIP Comments: Annular space needs to be grouted between the 12 and 14-inch pipes. FIELD_STRUCT_DESC: 12-inch steel irrigation pipe sleeved through the 14-inch pipe through the levee, 7 feet below the crown. Annular space not grouted. 36-inch concrete standpipe on the landside (LS) toe. [Additional Reference(s): DWR Levee Log, 1992. USACE Sacramento O&M Manual 113 (Revised), October 1966, (HLM 7.65), 12-inch pipe listed]. FS Date: 7/10/2013

12-inch pipe sleeved through 14-inch pipe at WS slope. Erosion around pipe on levee slopes-both sides of levee.

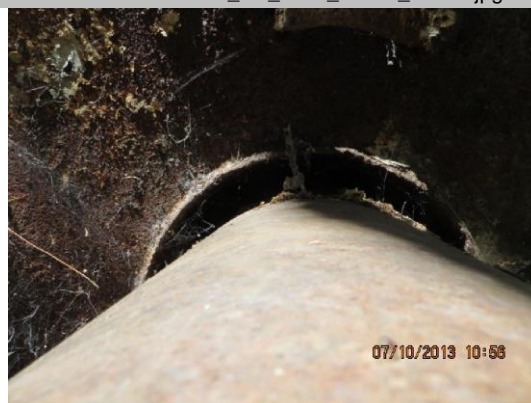
Photo 2 of 3 : UCIP_SP_2018_15624_25968.jpg

Notice: No grout between sleeved pipes.

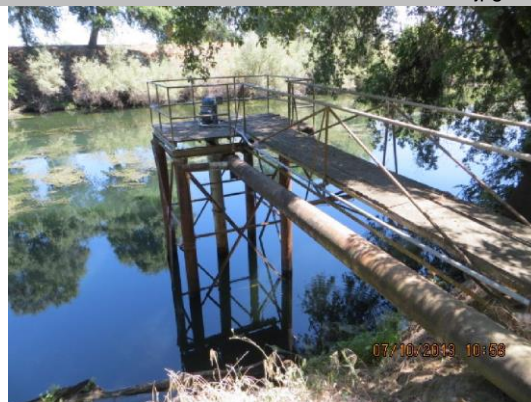
Photo 3 of 3 : UCIP_SP_2018_15624_25967.jpg

Pump on metal pier with walkway at WS toe

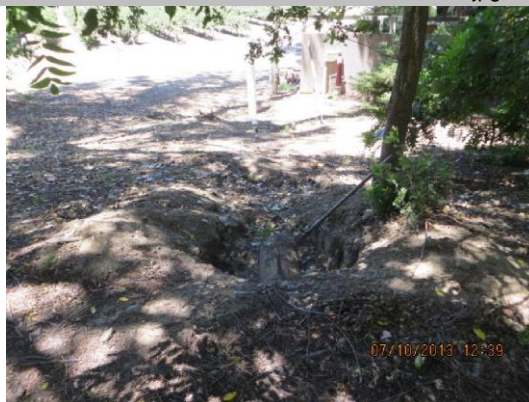
Photo 3 of 3 : UCIP_SP_2018_15683_26100.jpg

Comment Code						
Inspector Comment						
FS_ID:15683 DS_ID:22881 EP_NO: 13463 Repair Type: Non-Urgent Crossing Status: Found UCIP Comments: Pipe exposed in excavation on LS shoulder at what may be a leak. FIELD_STRUCT_DESC: 12-inch steel irrigation pipe through the levee, 2.5 feet below the crown. Pump on pile structure with walkway on the waterside (WS) toe. 12-inch polyvinyl chloride (PVC) standpipe on the landside (LS) toe next to filter plant and shed. 1.5-inch polyvinyl chloride (PVC) electrical conduit at the same location. (12-inch pipe authorized under Permit No. 13463, 1982 - John Plyman, existing 8-inch pipe was grouted in-place). FS Date: 7/10/2013

Pipe visible on LS shoulder with siphon breaker.

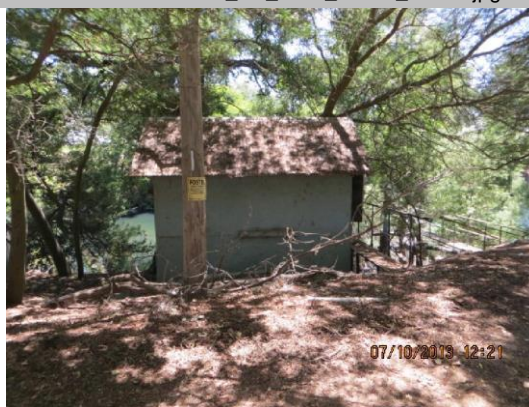
Photo 2 of 3 : UCIP_SP_2018_15663_26081.jpg

Concrete pumphouse on WS slope.

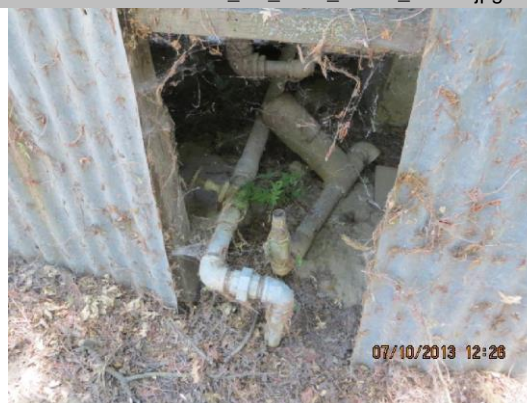
Photo 2 of 2 : UCIP_SP_2018_15664_26083.jpg

LM Start	8.05	Rating **	M	Issue No.	253 (cont)	
LM End	8.05	Issue Type +	En	Location *		
Category	Supplemental			GPS Latitude/Longitude		
				Start		End
Item	DWR UCIP Field Study			38.409488 °		38.409488 °
				-121.540833 °		-121.540833 °
DWR ID						
Comment Code						
Inspector Comment						
FS_ID:15664 DS_ID:22870 EP_NO: N/A Repair Type: Non-Urgent Crossing Status: Found UCIP Comments: Pipe appears abandoned and should be done so properly. FIELD_STRUCT_DESC: 2-inch galvanized iron domestic water line through the levee, 12.5 feet below the crown. Gate valve and domestic pressure system in pump house on the waterside (WS) slope. [Additional Reference(s): DWR Levee Log, 1992. USACE Sacramento O&M Manual 113 (Revised), October 1966, (HLM 8.14)]. FS Date: 7/10/2013

Pipe visible inside pumphouse on WS slope.

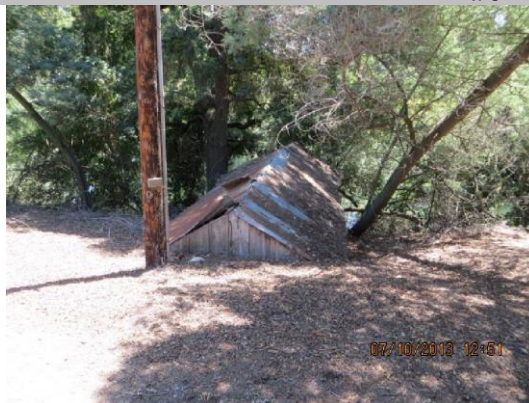
Photo 1 of 3 : UCIP_SP_2018_15685_26106.jpg

Comment Code					
Inspector Comment					
FS_ID:15685 DS_ID:22871 EP_NO: 4851 Repair Type: Non-Urgent Crossing Status: Found UCIP Comments: Pipe appears to be abandoned and should be done so properly. FIELD_STRUCT_DESC: 8-inch steel irrigation pipe through the levee, 6.2 feet below the crown. Gate valve in pump house on the waterside (WS) slope. Service poles on both slopes. (no permit found for the install of original 8-inch pipe; 20-foot section of existing 8-inch pipe was replaced with new 8-inch pipe work authorized under Permit No. 4851, 1965 - J. Plyman). [Additional Reference(s): DWR Levee Log, 1992. USACE Sacramento O&M Manual 113 (Revised), October 1966, (HLM 8.23)]. FS Date: 7/10/2013

Pumphouse/concrete headwall on WS slopt.

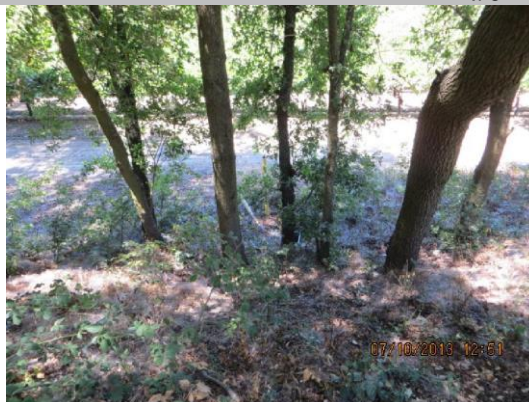
Photo 2 of 3 : UCIP_SP_2018_15685_26105.jpg

Possible location for original outlet on LS of Netherlands road.

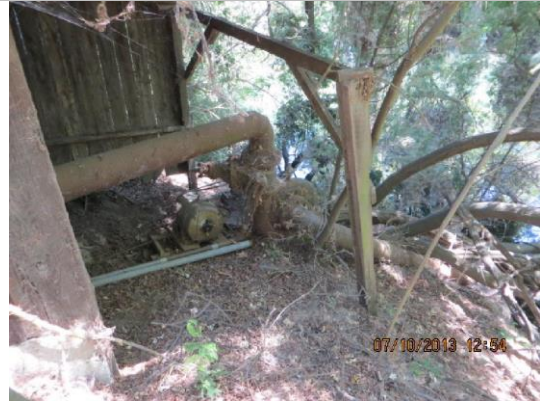
Photo 3 of 3 : UCIP_SP_2018_15685_26104.jpg

Comment Code						
Inspector Comment						
FS_ID:15685 DS_ID:22871 EP_NO: 4851 Repair Type: Non-Urgent Crossing Status: Found UCIP Comments: Pipe appears to be abandoned and should be done so properly. FIELD_STRUCT_DESC: 8-inch steel irrigation pipe through the levee, 6.2 feet below the crown. Gate valve in pump house on the waterside (WS) slope. Service poles on both slopes. (no permit found for the install of original 8-inch pipe; 20-foot section of existing 8-inch pipe was replaced with new 8-inch pipe work authorized under Permit No. 4851, 1965 - J. Plyman). [Additional Reference(s): DWR Levee Log, 1992. USACE Sacramento O&M Manual 113 (Revised), October 1966, (HLM 8.23)]. FS Date: 7/10/2013

Pump and gate valve in pump house on WS toe.

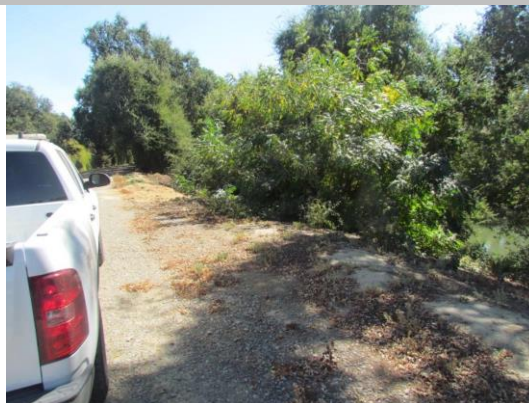
Photo 1 of 1 : SP_2018_RD0999_236_118_20180301_00058.jpg

LM Start	8.22	Rating **	U	Issue No.	118
LM End	8.22	Issue Type +	Ma	Location *	WS
Category	Earthen Levee			GPS Latitude/Longitude	
				Start	End
Item	Trim / Thin Trees			38.409665 °	38.409665 °
				-121.537898 °	-121.537898 °
DWR ID	DWR_RD0999_05_s_2012_118				
Comment Code					
T1 : Trim trees to at least five feet above ground level.					
Inspector Comment

Looking northeast at untrimmed trees on watward slope.

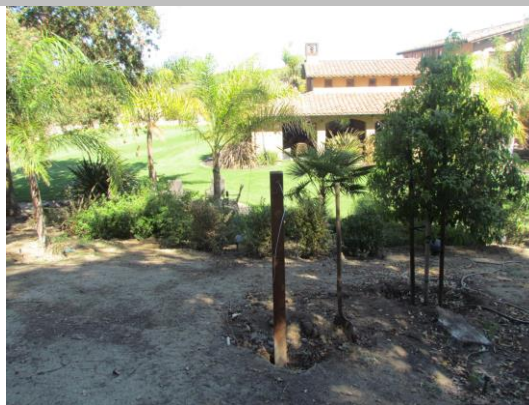
LM Start	8.27	Rating **	M	Issue No.	221
LM End	8.27	Issue Type +	En	Location *	LS
Category	Earthen Levee			GPS Latitude/Longitude	
				Start	End
Item	Encroachments			38.409468 °	38.409468 °
				-121.537066 °	-121.537066 °
DWR ID	DWR_RD0999_05_f_2016_221				
Comment Code					
PO : Pole					
Inspector Comment					
Landowner installed wooden poles on landside slope to hang lights

Looking east at wooden poles on landward shoulder.

Looking north at wooden pole on landward shoulder.

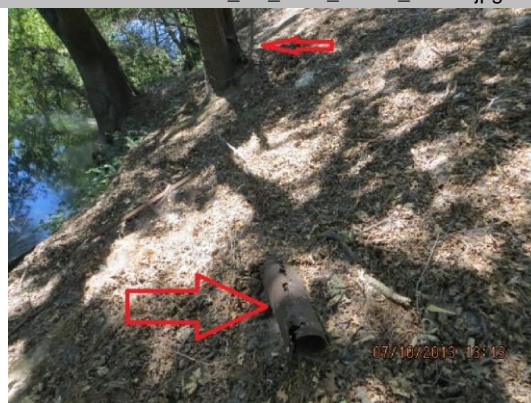
Photo 1 of 3 : UCIP_SP_2018_15686_26109.jpg

LM Start	8.29	Rating **	M	Issue No.	255
LM End	8.29	Issue Type +	En	Location *	
Category	Supplemental			GPS Latitude/Longitude	
				Start	End
Item	DWR UCIP Field Study			38.409264 °	38.409264 °
				-121.536659 °	-121.536659 °
DWR ID					
Comment Code					
Inspector Comment					
FS_ID:15686					
DS_ID:22872					
EP_NO: N/A					
Repair Type: Non-Urgent					
Crossing Status: Indicator Found					
UCIP Comments: Type of pipe abandonment needs to be verified.					
FIELD_STRUCT_DESC: *ABANDONED* 8-inch steel irrigation pipe through the levee, 11.7 feet below the crown. No control valves. 1.5-inch galvanized iron electrical conduit found on the waterside (WS) slope at oak tree. 8-inch pipe debris visible on the WS slope. [Additional					
Reference(s): DWR Levee Log, 1992. USACE Sacramento O&M Manual 113 (Revised), October 1966, (HLM 8.43)].					
FS Date: 7/10/2013

8-inch pipe debris with 1.5-inch electrical conduit visible in background on WS slope.

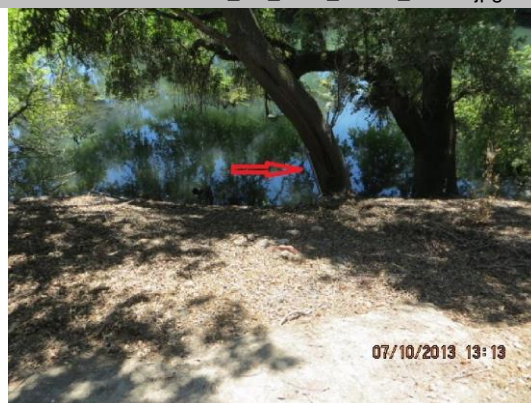
Photo 2 of 3 : UCIP_SP_2018_15686_26108.jpg

1.5-inch electrical conduit visible on WS slope next to oak.

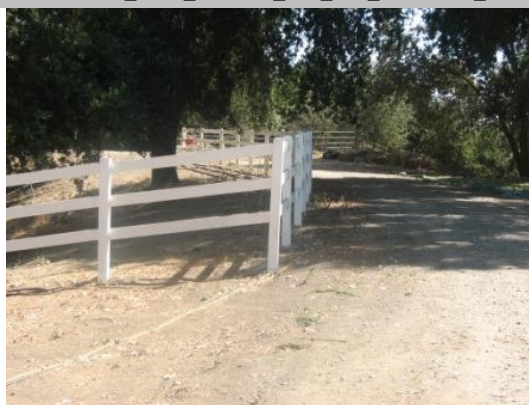
Photo 1 of 1 : SP_2018_RD0999_236_101_20180301_00053.jpg

LM Start	8.39	Rating **	M	Issue No.	101
LM End	8.43	Issue Type +	En	Location *	LS
Category	Earthen Levee			GPS Latitude/Longitude	
				Start	End
Item	Encroachments			38.408586 °	38.408748 °
				-121.534992 °	-121.534437 °
DWR ID	DWR_RD0999_05_s _ 2012_101				
Comment Code					
FE : Fence					
Inspector Comment					
Fence installed without CVFPB permit in 2008. Fence extends from landside toe to landside shoulder.

New installed unauthorized fence at landside slope and shoulder.

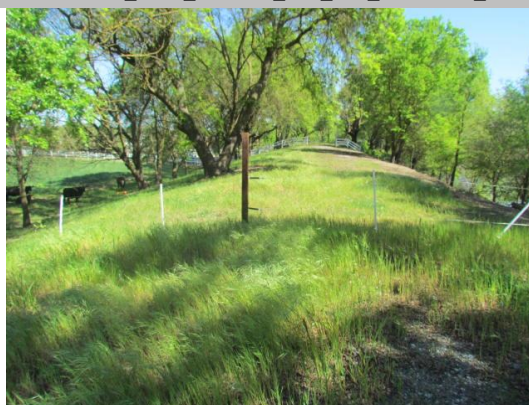
Photo 1 of 1 : SP_2018_RD0999_236_187_20180301_00102.jpg

LM Start	8.50	Rating **	M	Issue No.	187
LM End	8.50	Issue Type +	En	Location *	CR
Category	Earthen Levee			GPS Latitude/Longitude	
				Start	End
Item	Encroachments			38.409395 °	38.409395 °
				-121.533593 °	-121.533593 °
DWR ID	DWR_RD0999_05_s_2015_187				
Comment Code					
FE : Fence					
Inspector Comment					
Landowner installed a electrical fence across levee crown.

Looking east at new electrical fence across levee crown and landward slope. (Spring 2015)

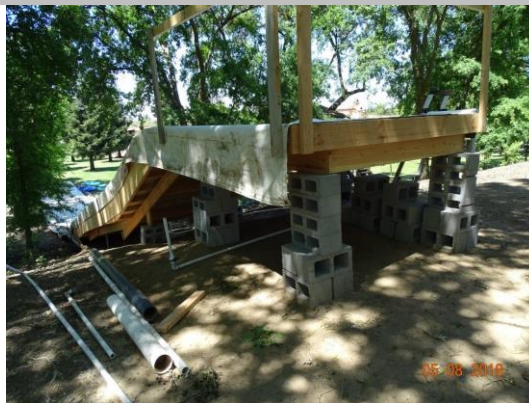
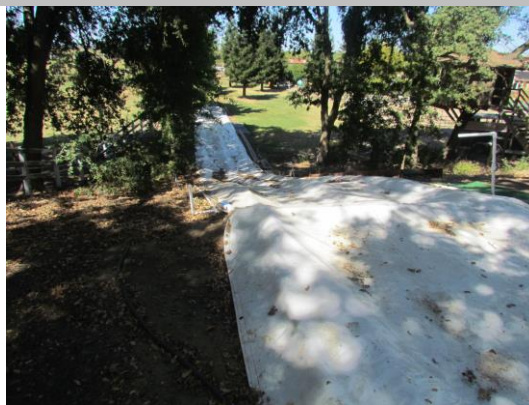
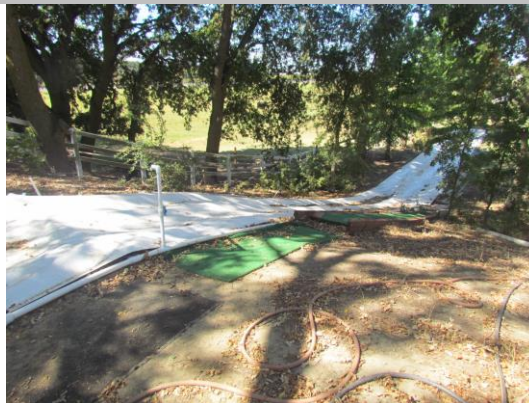
LM Start	8.54	Rating **	M	Issue No.	222
LM End	8.54	Issue Type +	En	Location *	LS
Category	Earthen Levee			GPS Latitude/Longitude	
				Start	End
Item	Encroachments			38.409931 °	38.409931 °
				-121.533033 °	-121.533033 °
DWR ID	DWR_RD0999_05_f_2016_222				
Comment Code					
PL : Pool					
Inspector Comment					
Landowner installed slip and slide and pvc pipes on landside slope.

Encroachment waterslide landside looking north.

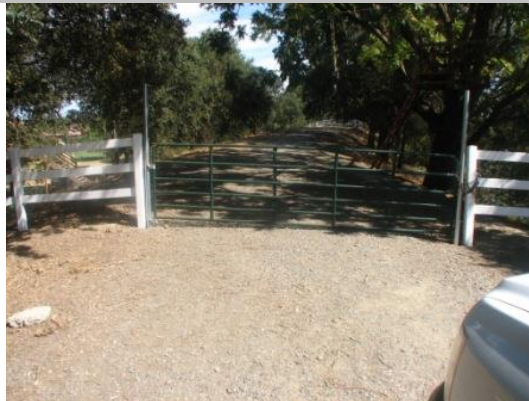
Photo 1 of 2 : SP_2018_RD0999_236_103_20180301_00054.jpg

LM Start	8.59	Rating **	M	Issue No.	103
LM End	8.59	Issue Type +	En	Location *	CR
Category	Earthen Levee			GPS Latitude/Longitude	
				Start	End
Item	Encroachments			38.410332 °	38.410332 °
				-121.532277 °	-121.532277 °
DWR ID	DWR_RD0999_05_s_2012_103				
Comment Code					
FE : Fence					
Inspector Comment

View of fence & gate across levee crown, landside & waterside slope.

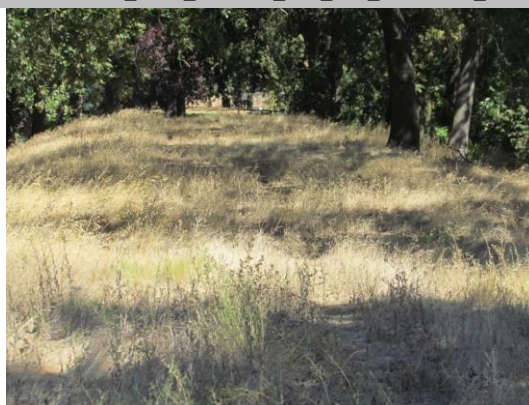
Photo 1 of 1 : SP_2018_RD0999_236_223_20180301_00125.jpg

LM Start	8.64	Rating **	M	Issue No.	223
LM End	8.72	Issue Type +	Ma	Location *	CR
Category	Earthen Levee			GPS Latitude/Longitude	
				Start	End
Item	Vegetation			38.410696 °	38.411560 °
				-121.531584 °	-121.530479 °
DWR ID	DWR_RD0999_05_f_2016_223				
Comment Code					
V9 : Keep the crown roadway free of vegetation.					
Inspector Comment					
Control growth on levee crown

Looking east at overgrowth on levee crown.

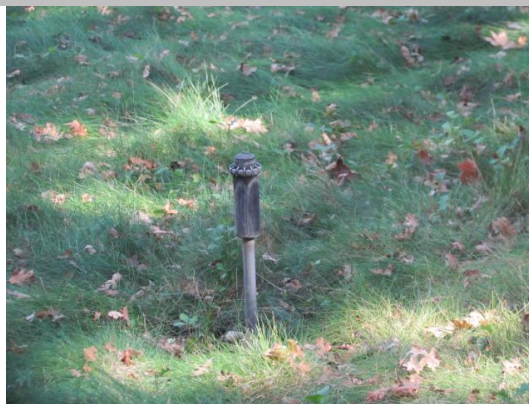
Photo 1 of 1 : SP_2018_RD0999_236_134_20180301_00064.jpg

LM Start	8.73	Rating **	M	Issue No.	134
LM End	8.82	Issue Type +	En	Location *	LS
Category	Earthen Levee			GPS Latitude/Longitude	
				Start	End
Item	Encroachments			38.411577 °	38.412619 °
				-121.530375 °	-121.529691 °
DWR ID	DWR_RD0999_05_f_2012_134				
Comment Code					
LI : Landscape Irrigation					
Inspector Comment					
Sprinklers on landside and waterside shoulder.

Looking at one of several sprinklers on waterward and landward slope.

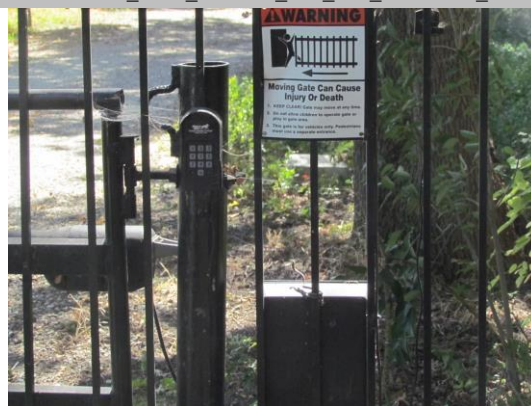
Photo 1 of 2 : SP_2018_RD0999_236_224_20180301_00126.jpg

LM Start	8.82	Rating **	M	Issue No.	224
LM End	8.82	Issue Type +	En	Location *	CR
Category	Earthen Levee			GPS Latitude/Longitude	
				Start	End
Item	Encroachments			38.412718 °	38.412718 °
				-121.529724 °	-121.529724 °
DWR ID	DWR_RD0999_05_f_2016_224				
Comment Code					
FE : Fence					
Inspector Comment					
Landowner installed gate across levee crown.

Looking at code pad on right side of gate.

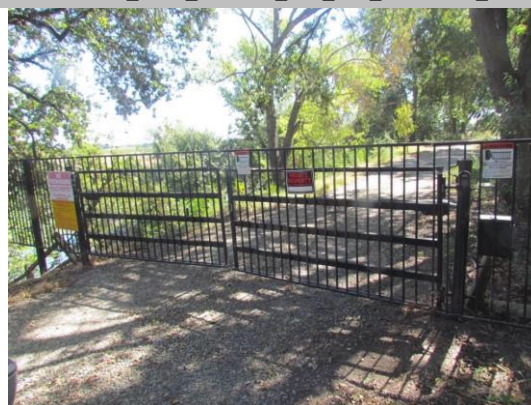
Photo 2 of 2 : SP_2018_RD0999_236_224_20180301_00127.jpg

LM Start	8.82	Rating **	M	Issue No.	224 (cont)
LM End	8.82	Issue Type +	En	Location *	CR

Looking west at code pad on right side of gate.

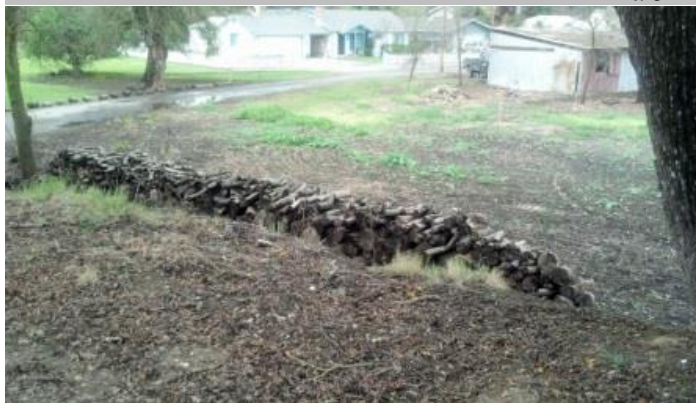
Photo 1 of 2 : SP_2018_RD0999_236_145_20180301_00066.jpg

LM Start	9.44	Rating **	M	Issue No.	145
LM End	9.44	Issue Type +	En	Location *	LS
Category	Earthen Levee			GPS Latitude/Longitude	
				Start	End
Item	Encroachments			38.413755 °	38.413755 °
				-121.523723 °	-121.523723 °
DWR ID	DWR_RD0999_05_s_2013_145				
Comment Code					
FW : Firewood					
Inspector Comment					
Firewood stockpile at landside toe next to ramp.

Looking north at firewood piled at landside toe.
